# Failure and Technology Analysis

Services Failure & Technology Analysis

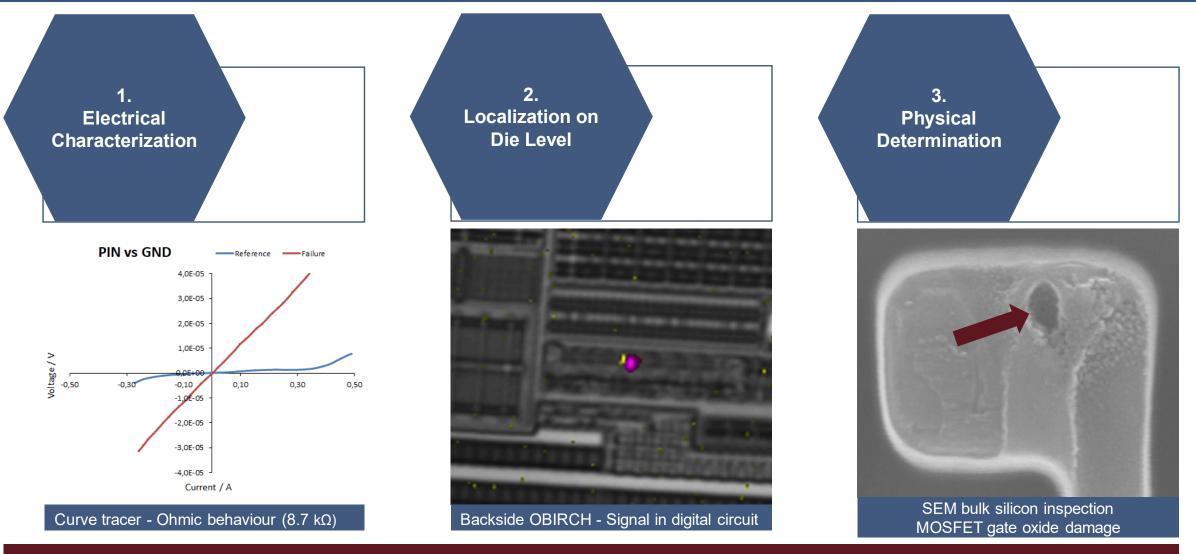
#### **Failure Analysis – Integrated Circuit**

Root cause: ESD induced gate oxide breakdown

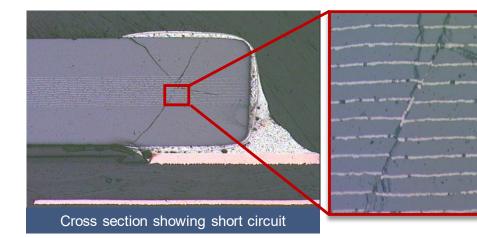
### Failure Analysis – Ceramic Capacitor

Cracks after removal of metallization

#### Sources of mechanical overstress:

- Board assembly
- Singulation of a multi panel
- Assembly of components in press-fit technology
- Assembly in the system (e.g. screwed connections)
- Temperature change loads of fully molded printed circuit board assemblies

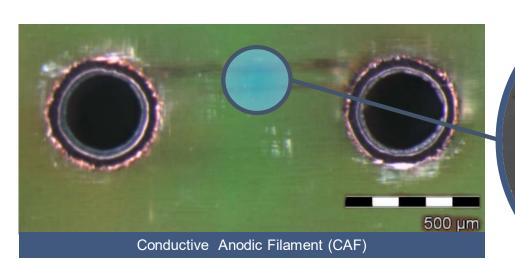
## Failure Analysis – Printed Circuit Board Assembly (PCBA)

Cross section of poor solder joint and the resulting failure (thermal overstress)

Cracks in solder joints, tracks and microvia

Typical failures on PCBA-Level:			
•	Whisker growth	•	Material migration
•	Conductive Anodic	•	Insufficient solder joints
	Filaments (CAF)	-	Cracks in solder joints,
•	Delamination		tracks and vias
-	Dendrite formation

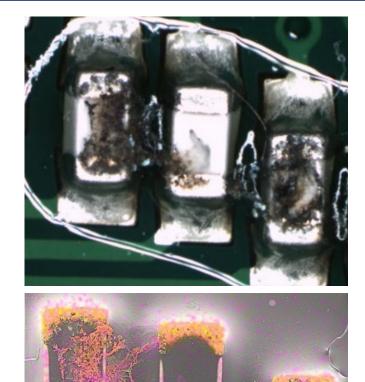
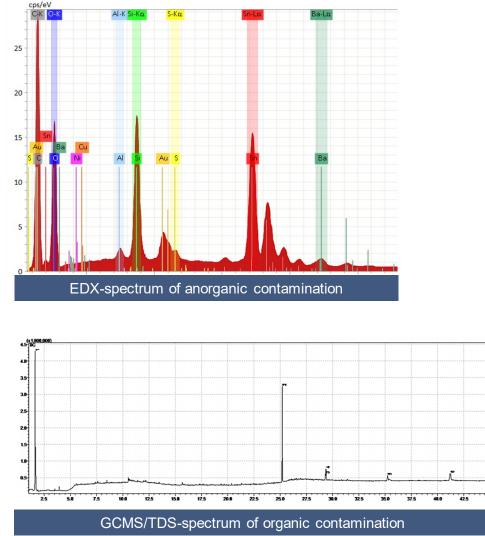
### **Technology Analysis – Material Analysis**

#### Measurement of ionic contamination

EDX-mapping - migration (copper and nickel)

Ch 1 Ni Sn Cu 118 MAG: 79X HV: 20 kV WD: 10,0 mm

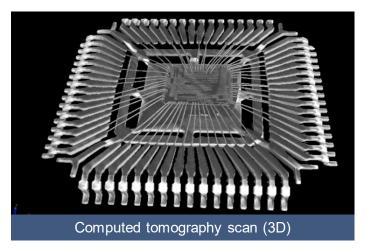
X-ray microscopy (2D)

Examination of test specimens without destruction, enables analyses without direct intervention on potential defect positions

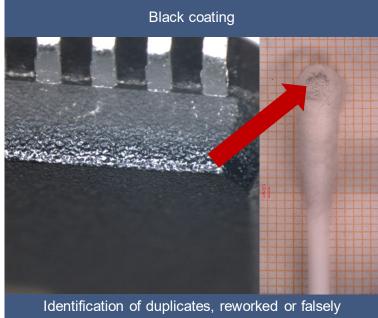
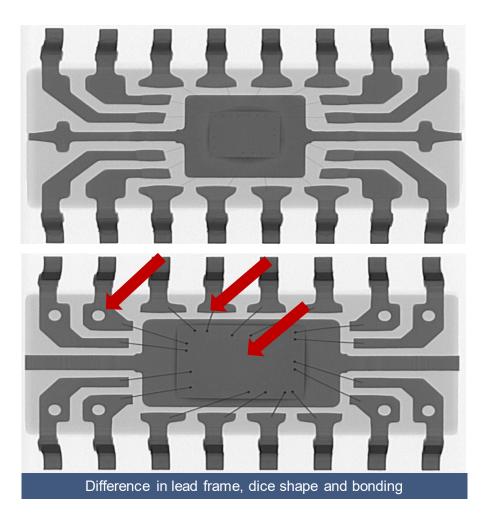
#### **Counterfeit Component Analysis**

#### Inspection methods:

- Light-optical inspection of the housing and the terminal metallization
- X-ray microscopy to inspect the lead frame and bonding
- Solvent wiping test to identify blacktopping
- Wet chemical exposure of the die
