Burning Ceramic Capacitors: Reasons, Risks, and Solutions

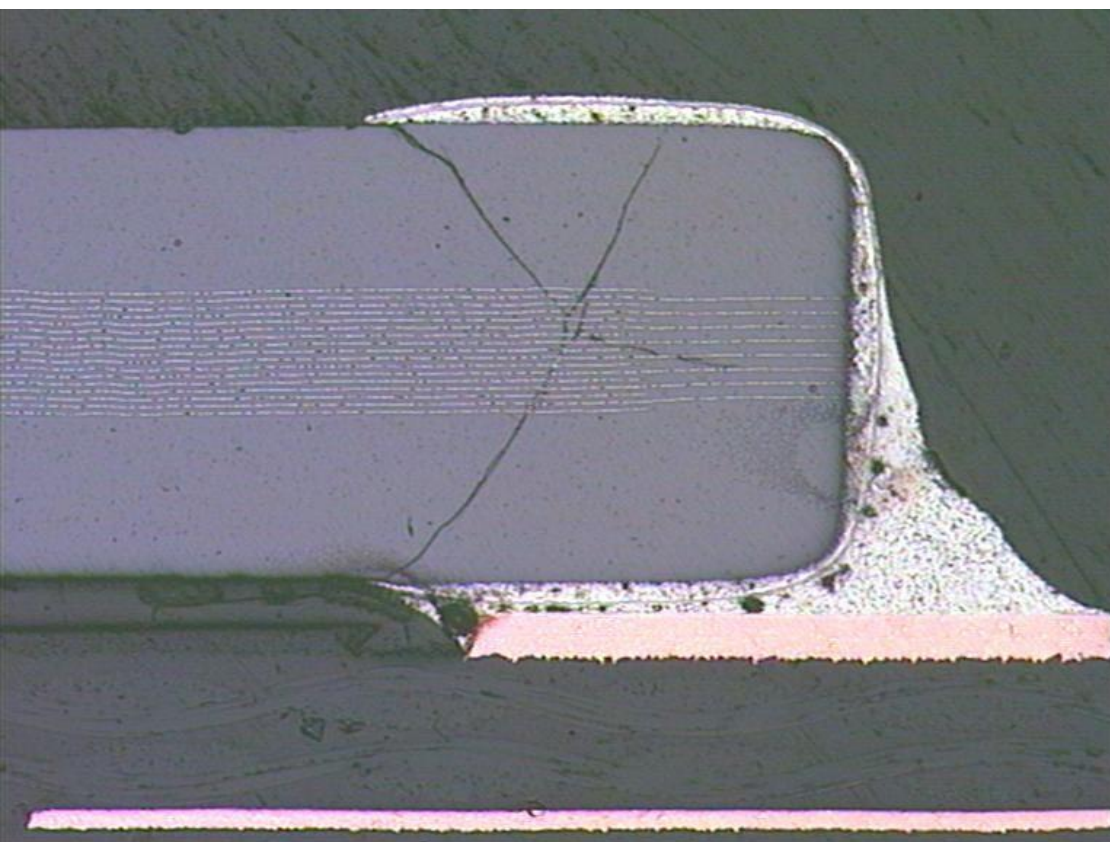
Cracking of ceramic capacitors typically starts at the edge of the solder joint on the bottom of the capacitor and runs slanted into the terminal cap.

Within the application, the electrode material is at risk to spread along these cracks. As soon as two adjacent electrodes are connected, the ceramic capacitor turns into a resistor. If this resistor is low-ohmic and the energy source has enough power, this can lead to destruction and even fire.

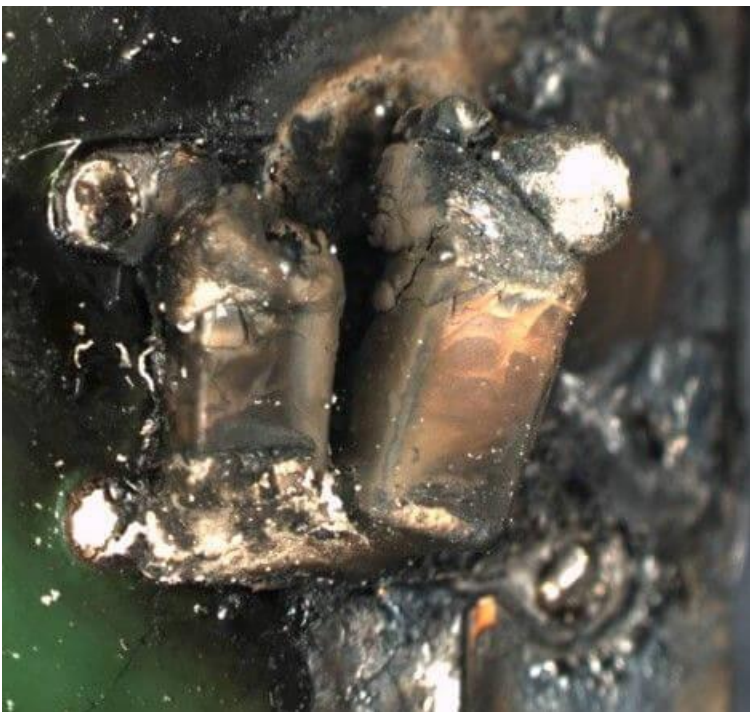
As an alternative, RoodMicrotec offers a test method in which the terminal metallization of the component is etched off and then subjected to an optical inspection. This ensures a clear detection, as cracks always occur on the surface of the component and are located at the edge of the terminal metallization.

Furthermore, a significant advantage of this method is the possibility to infer mechanical stress from the position of the cracks. Cracks caused by bending stresses often run along the entire length of a connection. In the case of torsional stress, usually both connections are affected, with the cracks occurring at the opposite corners, respectively.
